OPEL Astra: 1HXT195

Limited Technical Inspection

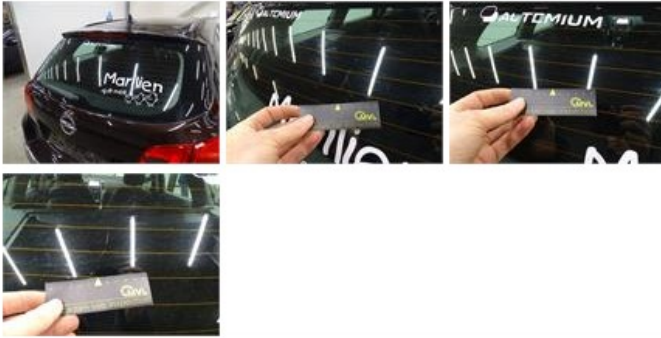
Rear window, Scratch(es), E - Replace	370,00
---------------------------------------	--------
