PEUGEOT 308 SW: 1LVZ647

Limited Technical Inspection

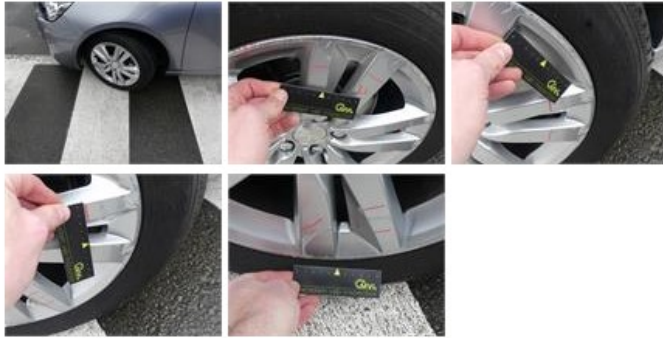
Alloy rim F L, Scratch(es), LI - Repair and paint (complete) 95,00

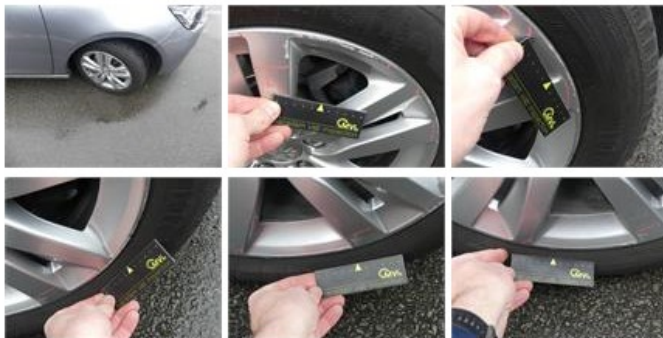
Alloy rim F R, Scratch(es), LI - Repair and paint (complete) 95,00

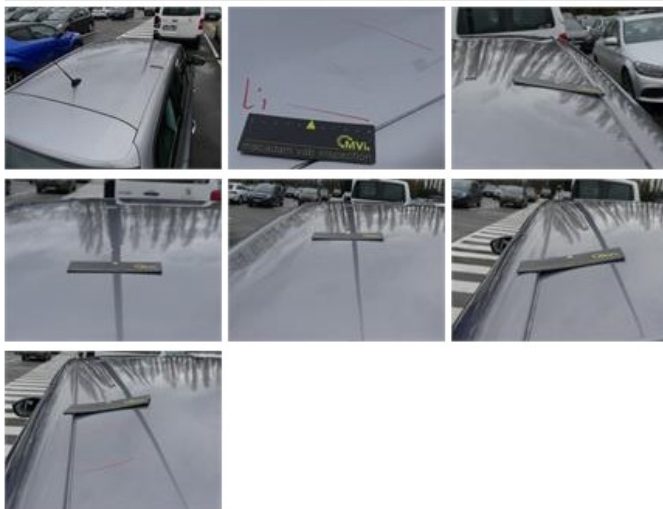
Roof, Dent(s) and scratch(es), LI - Repair and paint (complete) 481,50
