VOLVO XC60: 1HAV977

Limited Technical Inspection

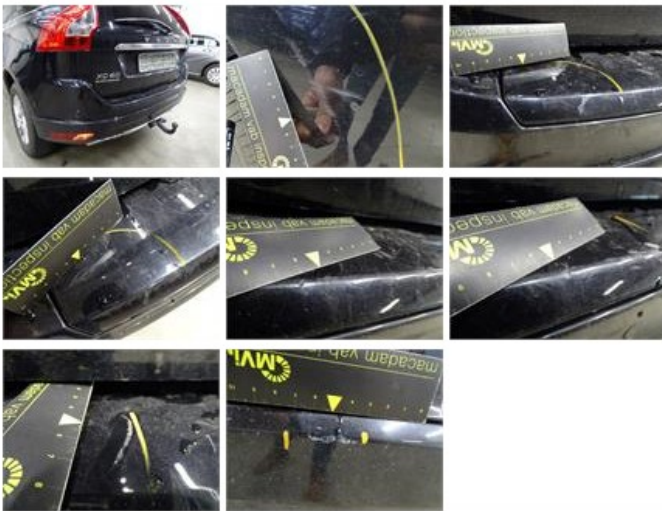
Bumper R, Scratch(es), LI - Repair and paint (complete) 254,16

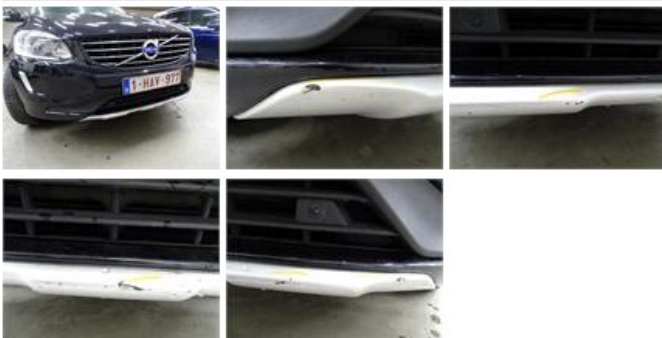
Bumper spoiler F, Scratch(es), It - Spot repair 115,56
