**BMW 1 HATCH: YX7308**

**Limited Technical Inspection**

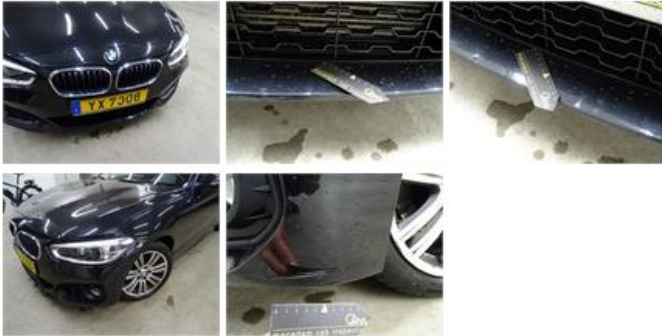
Bumper F, Dent(s) and scratch(es), LI - Repair and paint (complete)
