**VOLVO V60: 1LSY757**

**Limited Technical Inspection**

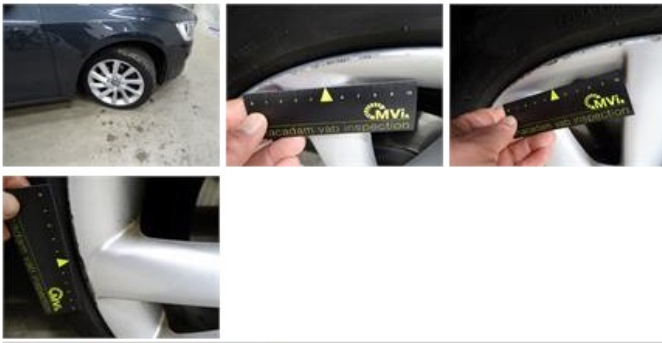
<b>Total cost ex VAT</b>	<b>401,80</b>
<b>Alloy rim F R, Scratch(es), LI - Repair and paint (complete)</b>	<b>95,00</b>

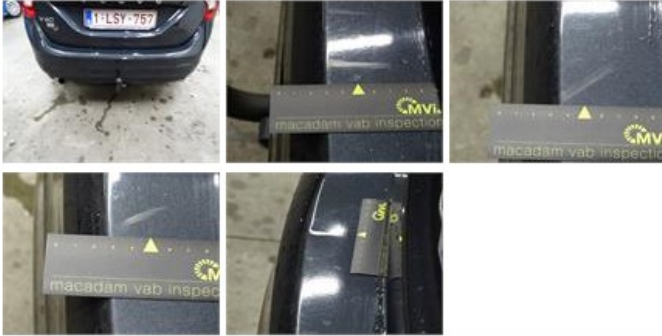
Bumper R, Dent(s) and scratch(es), LI - Repair and paint (complete) 211,80
