BMW 3: 1G8M423

Vinnumber:	WBA3D11020J626257	Versionname:	3 BER 318d 136PK
First Registrationdate:	10/02/2014	Fiscalpower:	
Expertise Mileage:	111591	Power Kw:	100
Bodytype:		Body color:	Brown
Gearbox:	MAN 6 VIT	Paint type:	Metalic
Transmission:	Back	Rims summer:	Aluminium
Fueltype:	Diesel	Oil level:	OK
Battery functioning:	No	Parking lot:	4114
Number of doors:	4		
Number of seats:	5		
Number head rests:	5		
Rims summer:	Aluminium		
Category:	Passenger Car		
Oil level:	OK		
Registration Certificate Car (BE):	Yes

Limited Technical Inspection

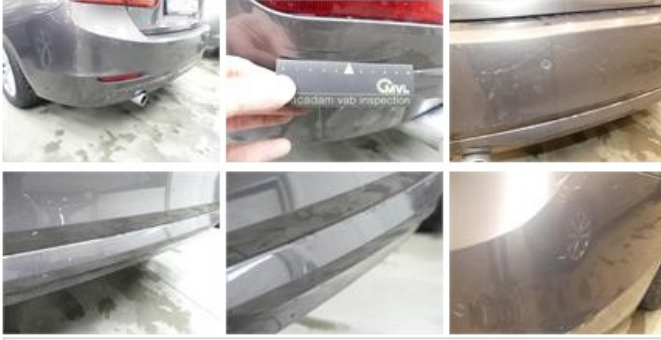
Bumper R, Dent(s) and scratch(es), LI - Repair and paint (complete) 211,80
