MERCEDES SPRINTER: 1NGZ295

Vinnumber:	WDB9066331P238416	Versionname:	1.8 16V CNG 316 NGT BI-FUEL A2H1 3.5T
First Registrationdate:	23/02/2016	Fiscalpower:	
Expertise Mileage:	58143	Power Kw:	115
Bodytype:		Body color:	Black
Gearbox:	Automatic	Paint type:	Metalic
Transmission:	Back	Rims summer:	Steel
Fueltype:	Diesel	Oil level:	OK
Maintenance	- 425 DAGEN	Parking lot:	LCV30
Maintenance	NOT OK		
Battery functioning	Yes		
Number of doors	5		
Number of seats	3		
Number head rests	3		
Rims summer	Steel		
Category	Light Commercial Vehicle		
Oil level	OK		
Registration Certificate Car (BE)	Yes

Limited Technical Inspection

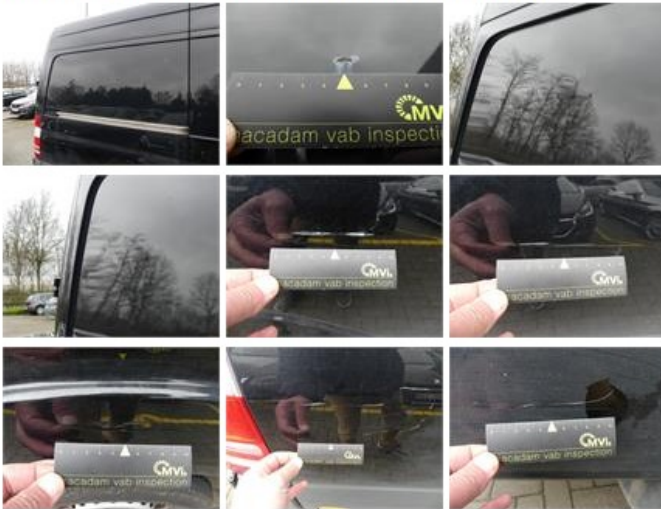
Wing R R, Dent(s) and scratch(es), LI - Repair and paint (complete) 327,15

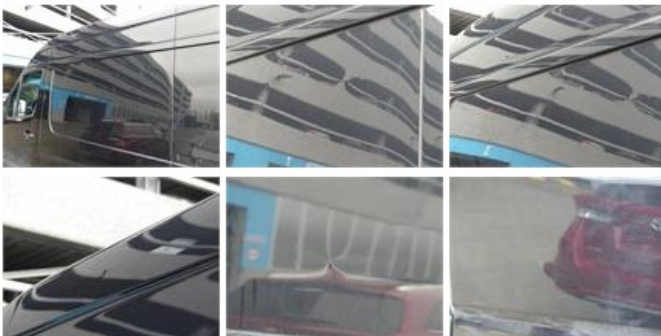
Sidewall mid L (LCV) , Dent(s) and scratch(es), LI - Repair and paint (complete) 478,02

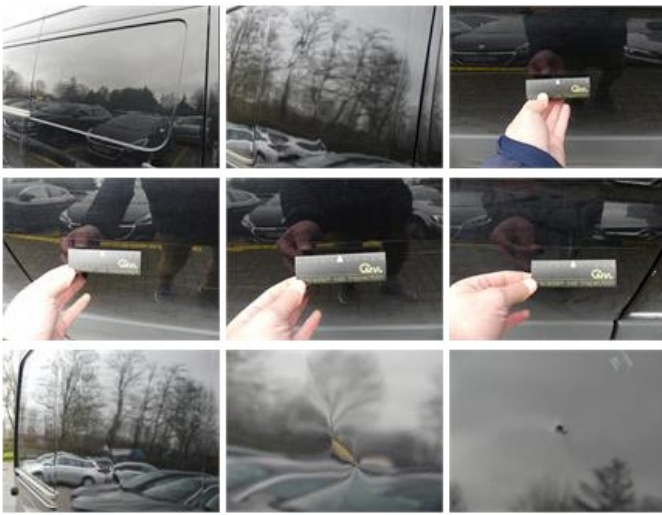
Sliding door R, Dent(s) and scratch(es), LI - Repair and paint (complete) 526,02

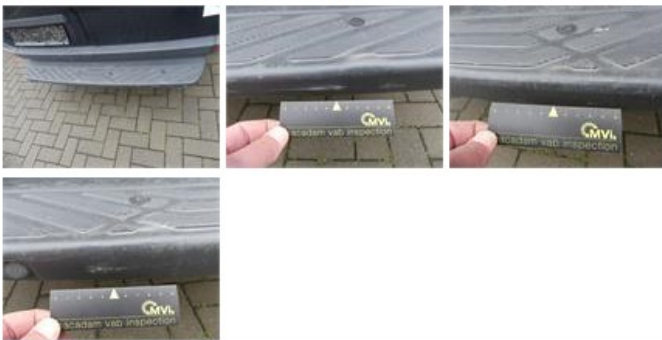
Bumper R, Deformed / Strained, E - Replace 329,40

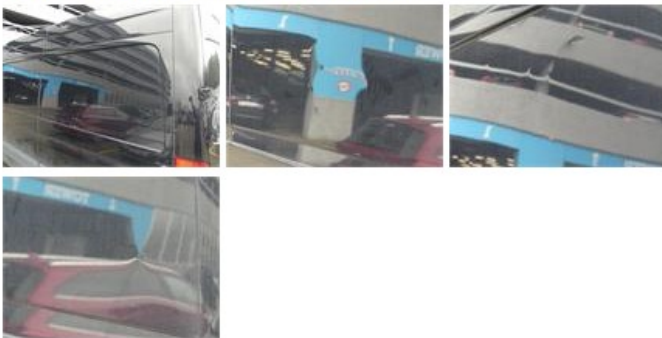
Wing R L, Dent(s), LI - Repair and paint (complete) 327,15
