SKODA RAPID SPACEBACK: 1NGU449

Limited Technical Inspection

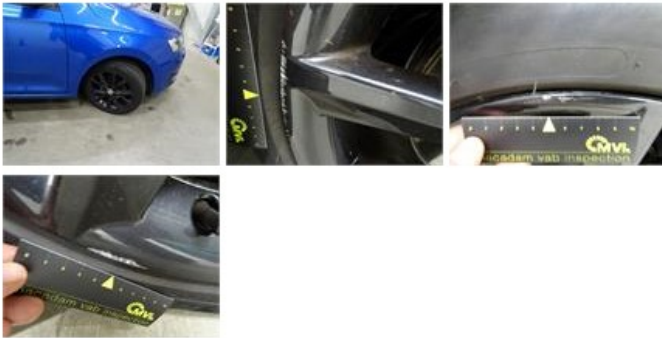
Alloy rim F R, Scratch(es), LI - Repair and paint (complete) 95,00

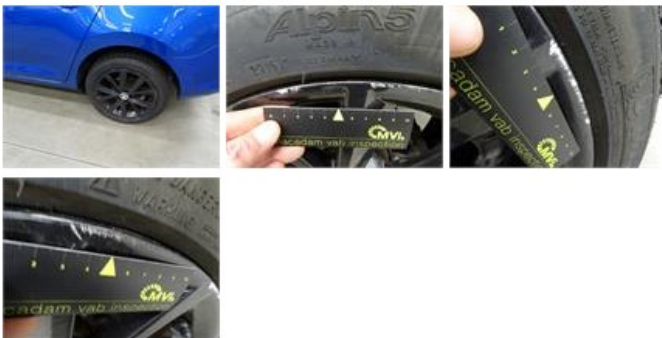
Alloy rim R L, Scratch(es), LI - Repair and paint (complete) 95,00

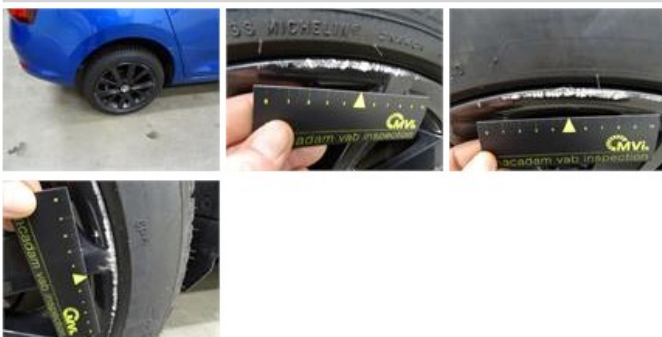
Alloy rim R R, Scratch(es), LI - Repair and paint (complete) 95,00
