SKODA Superb: 1GMV259

Limited Technical Inspection

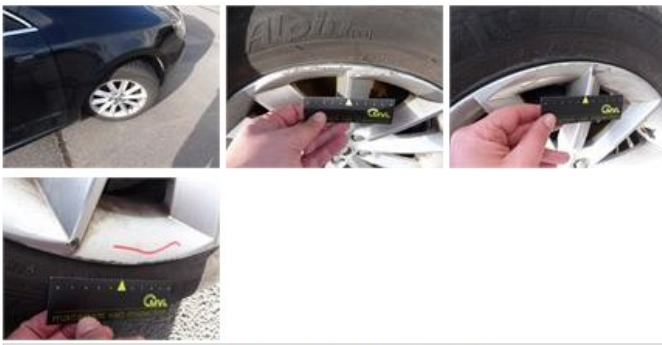
Total cost ex VAT	910,80
Alloy rim F R, Scratch(es), LI - Repair and paint (complete)	95,00

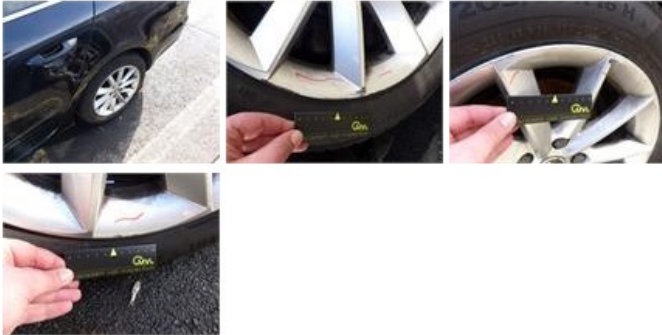
Alloy rim R L, Scratch(es), LI - Repair and paint (complete) 95,00

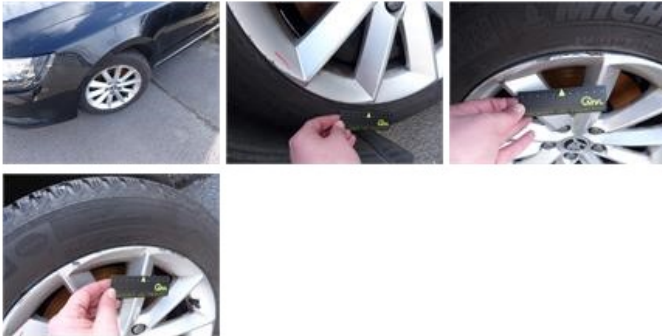
Alloy rim F L, Scratch(es), LI - Repair and paint (complete) 95,00
