SKODA OCTAVIA COMBI: 1JSP584

Limited Technical Inspection

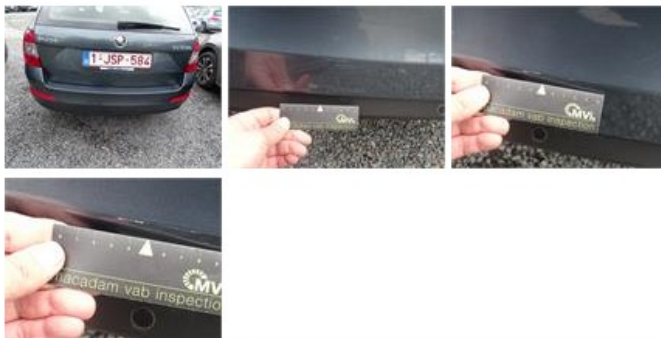
Bumper R, Scratch(es), LI - Repair and paint (complete)

211,80
