**AUDI A3 SPORTBACK: 1JUS352**

| Vinnumber: | <b>WAUZZZ8V8FA128116</b> | Versionname: | <b>1.6 TDI 81KW ATTRACTION</b> |

**Limited Technical Inspection**

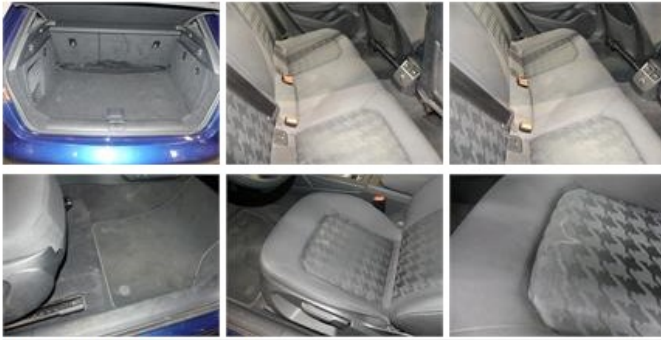
| Interior Stain, Cleaning | <b>40,00</b> |

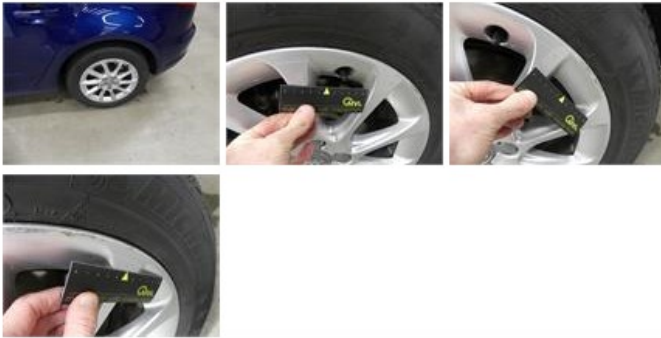
Alloy rim RL, Scratch(es), LI - Repair and paint (complete) 95,00

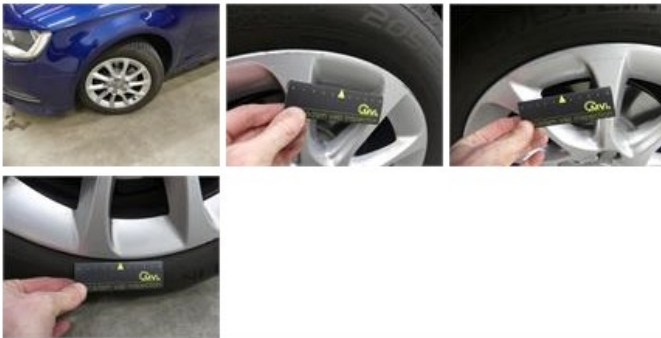
Alloy rim FL, Scratch(es), LI - Repair and paint (complete) 95,00
