**AUDI Q3: 1LTY266**

**Limited Technical Inspection**

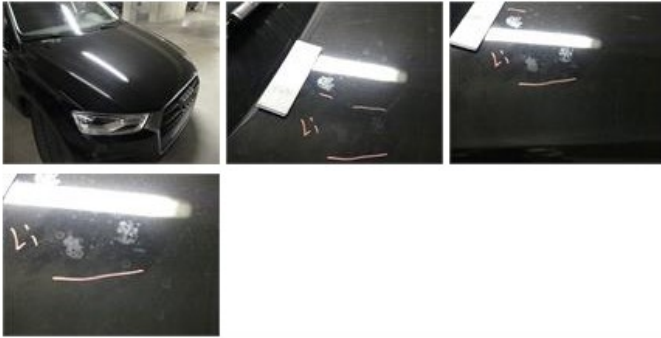
Bonnet, Chemical polution, LI - Repair and paint (complete)

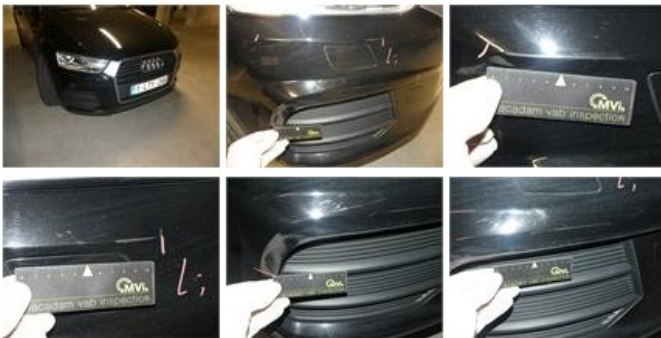
Bumper F, Scratch(es), LI - Repair and paint (complete)
