BMW 5 TOURING: 1LNU152

Limited Technical Inspection

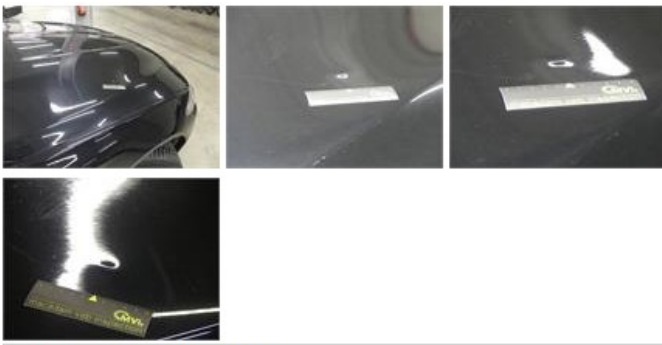
Bonnet, Dent(s), PDR - Paintless dent repair	63,00
--	--------------

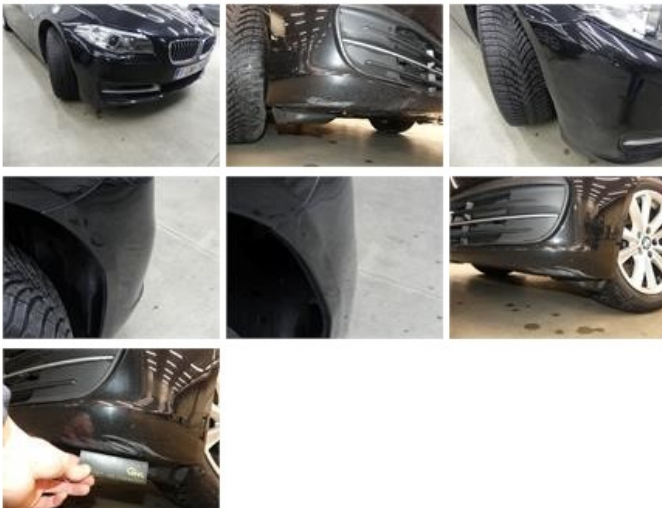
Bumper F, Dent(s) and scratch(es), LI - Repair and paint (complete) 302,16

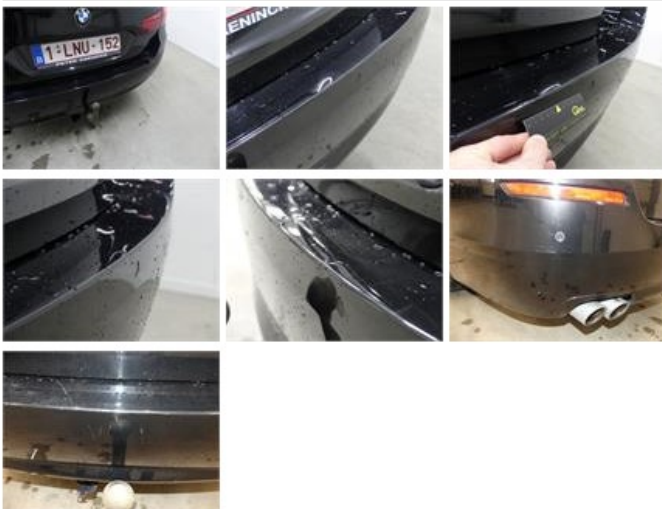
Bumper R, Dent(s) and scratch(es), LI - Repair and paint (complete) 254,16
