BMW 1 HATCH: 1PVG719

Limited Technical Inspection

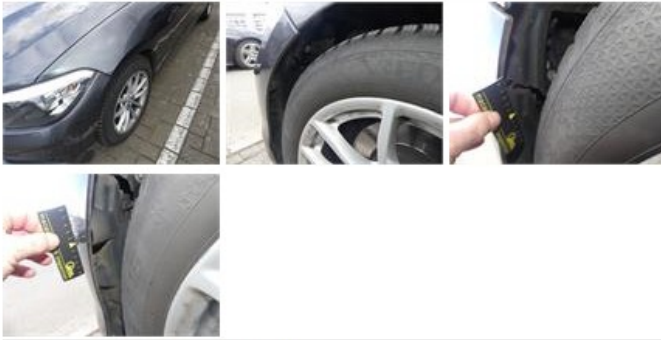
Wheel arch cover FL, Broken, E - Replace 63,06

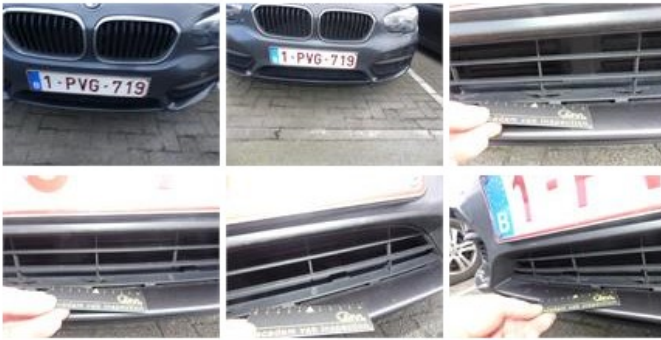
Grille, Broken, E - Replace 120,25

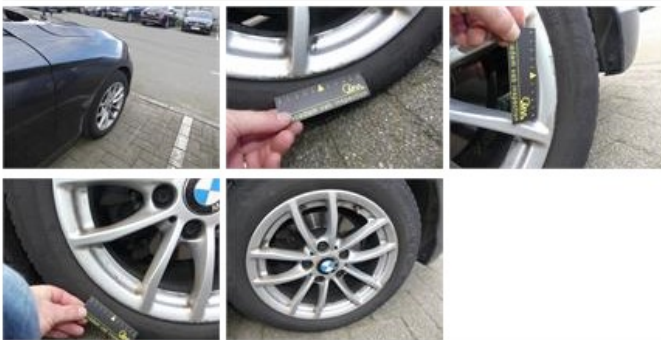
Alloy rim FR, Scratch(es), LI - Repair and paint (complete) 95,00

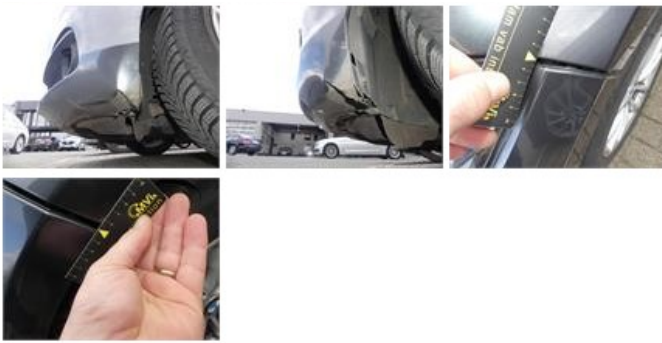
Bumper F, Dent(s) and scratch(es), Le - Replace and paint 735,00

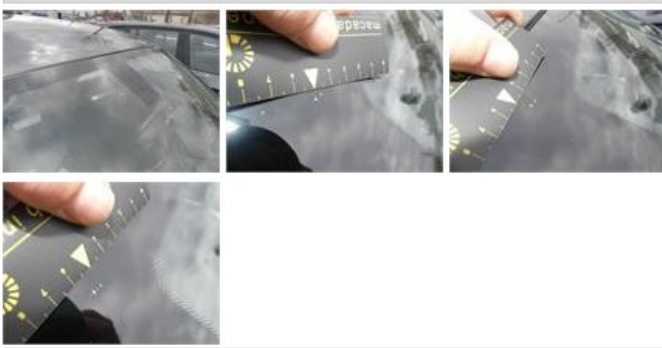
Windscreen, Stone chip(s), E - Replace	487,20
--	--------

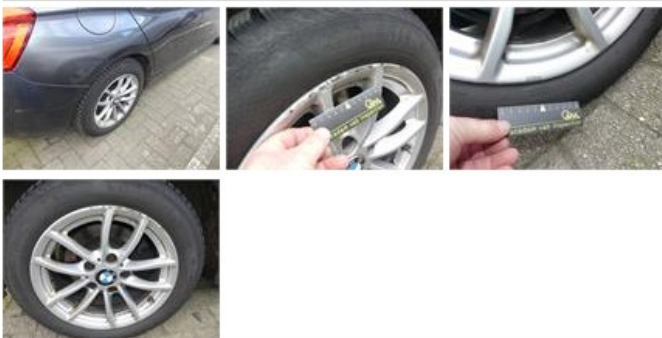
Alloy rim RR, Scratch(es), LI - Repair and paint (complete)	95,00
---	-------
