VOLKSWAGEN Polo: 1CER894

Limited Technical Inspection

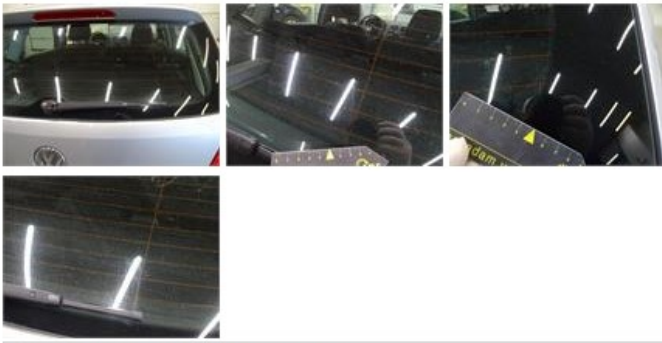
Rear window, Scratch(es), E - Replace	320,00
---------------------------------------	--------

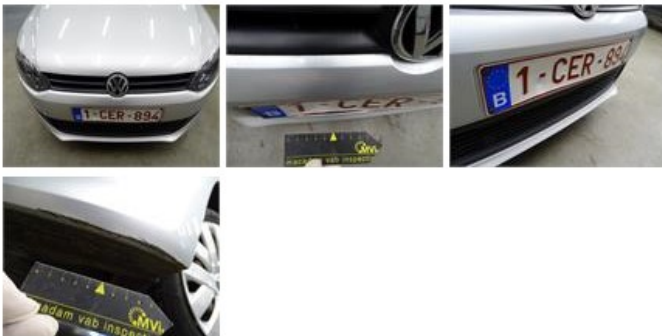
Bumper F, Dent(s) and scratch(es), LI - Repair and paint (complete) 169,44
