BMW 2 GRAN TOURER: 1LUB660

Vinnumber:	WBA2E510505C92754	Versionname:	2.0 218D (100KW) GRAN TOURER
First Registrationdate:	4/12/2015	Fiscalpower:	
Expertise Mileage:	100225	Power Kw:	100
Bodytype:		Body color:	Grey
Gearbox:	MAN 6 VIT	Paint type:	Metalic
Transmission:	Front	Rims summer:	Aluminium
Fueltype:	Diesel	Oil level:	OK
Battery functioning:	Yes	Parking lot:	3210
Number of doors:	5		
Number of seats:	7		
Number head rests:	7		
Rims summer:	Aluminium		
Category:	Passenger Car		
Oil level:	OK		
Registration Certificate Car (BE):	Yes

Limited Technical Inspection

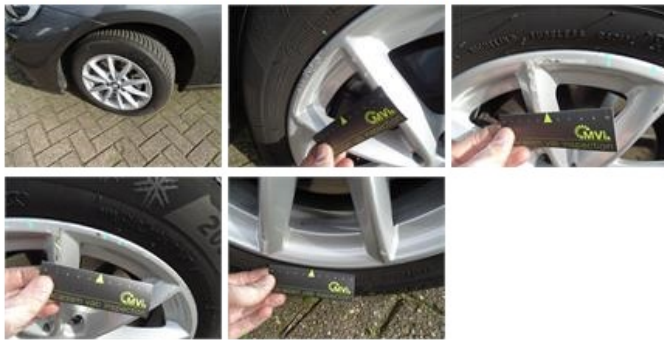
Alloy rim FL, Scratch(es), LI - Repair and paint (complete)

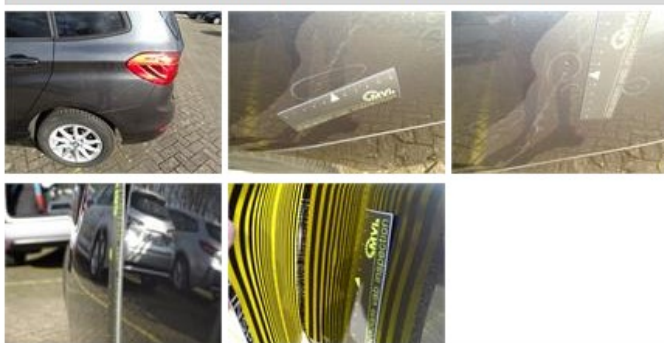
Wing RL, Dent(s) and scratch(es), LI - Repair and paint (complete)

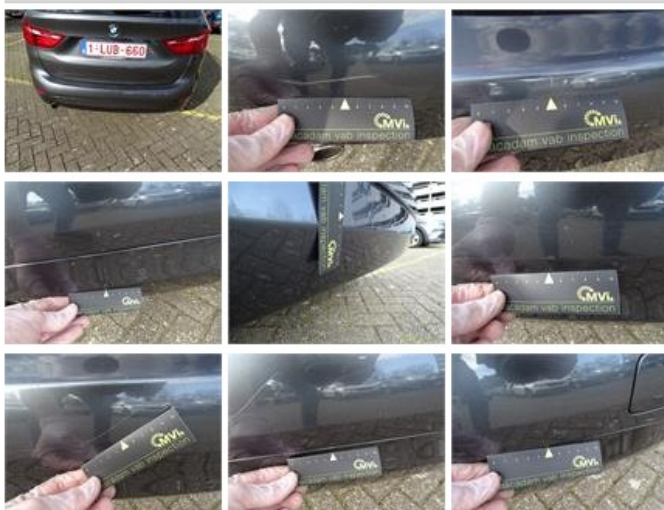
Bumper R, Scratch(es), LI - Repair and paint (complete)

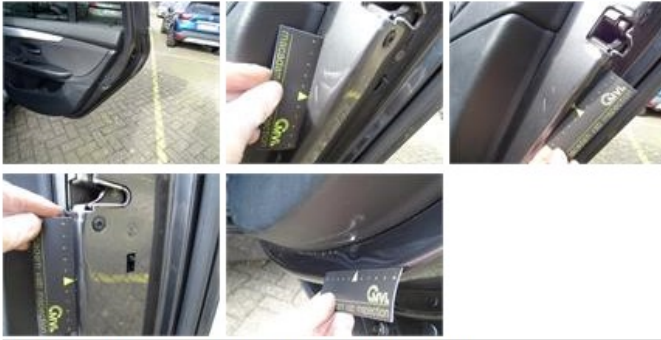
Door frame RR, Dent(s), It - Spot repair

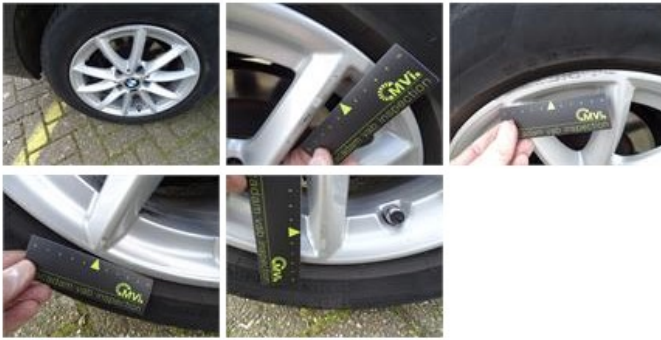
Alloy rim RR, Scratch(es), LI - Repair and paint (complete)

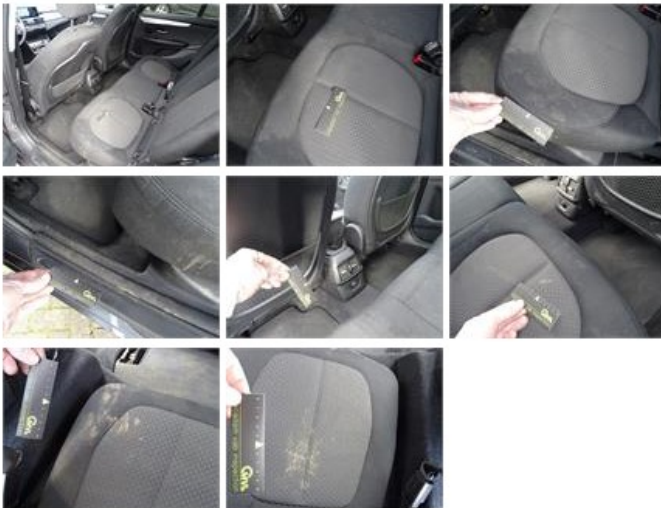
Interior, Dirty, Cleaning

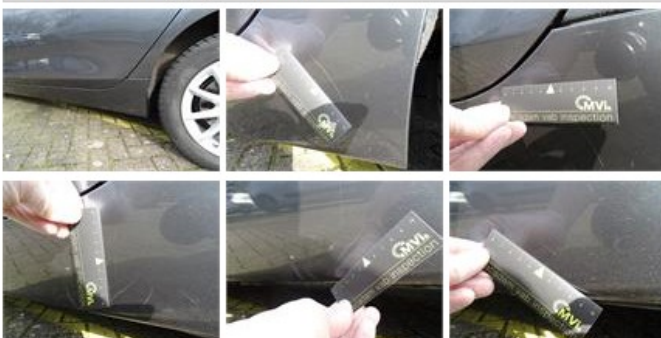
Outer sill L, Scratch(es), It - Spot repair

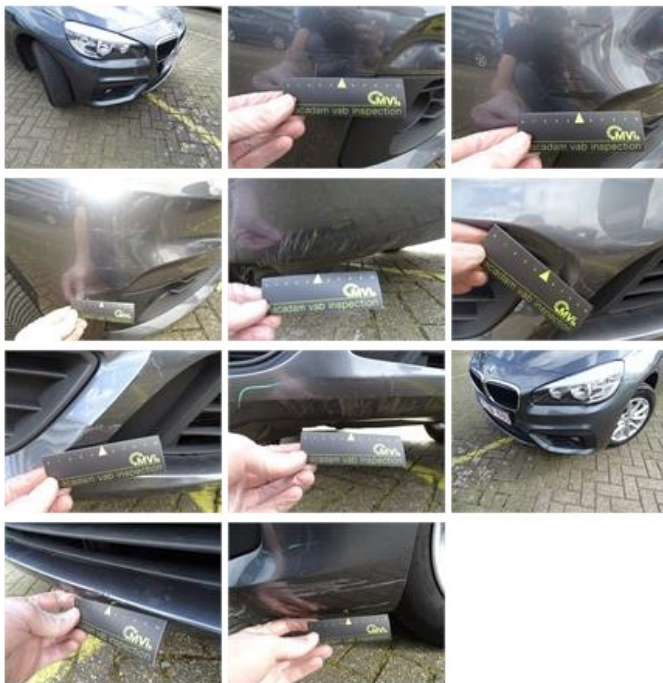
Bumper F, Dent(s) and scratch(es), LI - Repair and paint (complete)

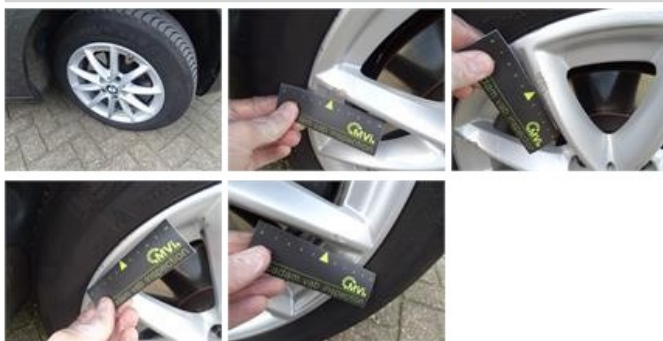
Alloy rim FR, Scratch(es), LI - Repair and paint (complete)
