**TOYOTA AURIS TOURING SPORTS: 1RBT489**

**Limited Technical Inspection**

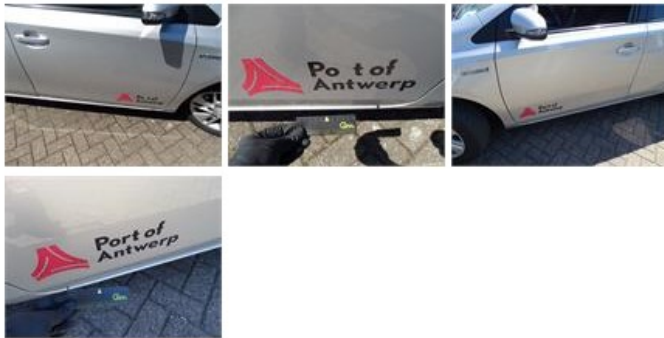
Bodywork, Not original part, P - Check 0,00

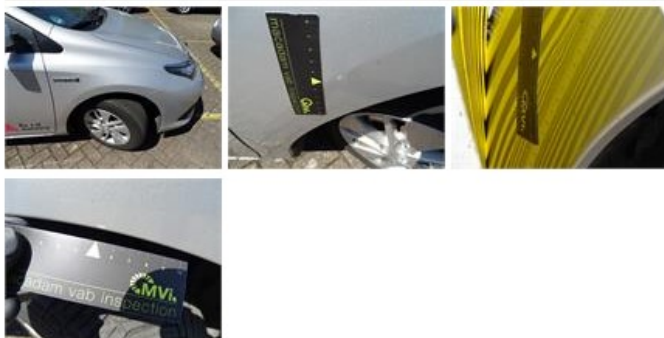
Wing FR, Dent(s) and scratch(es), LI - Repair and paint (complete) 0,00

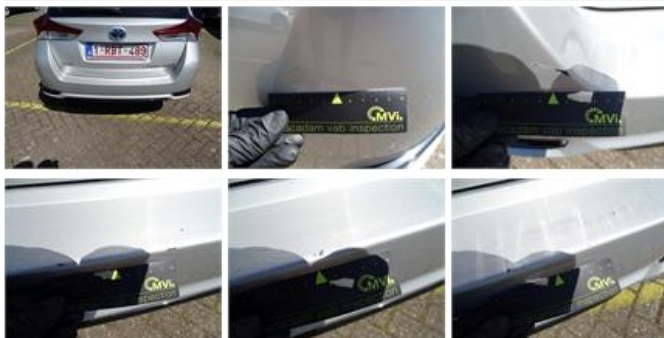
Bumper R, Scratch(es), LI - Repair and paint (complete) 0,00

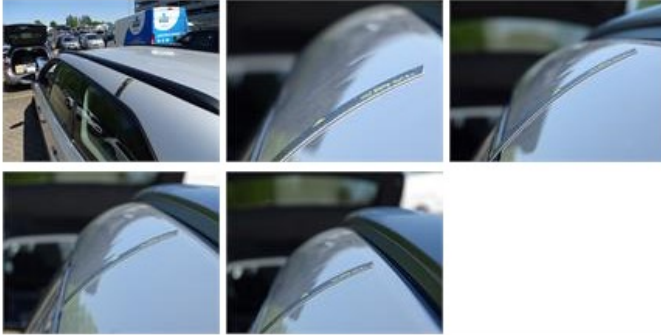
Roof pillar L, Dent(s), PDR - Paintless dent repair 69,30
