**MERCEDES C BERLINE: 1RBV263**

**Limited Technical Inspection**

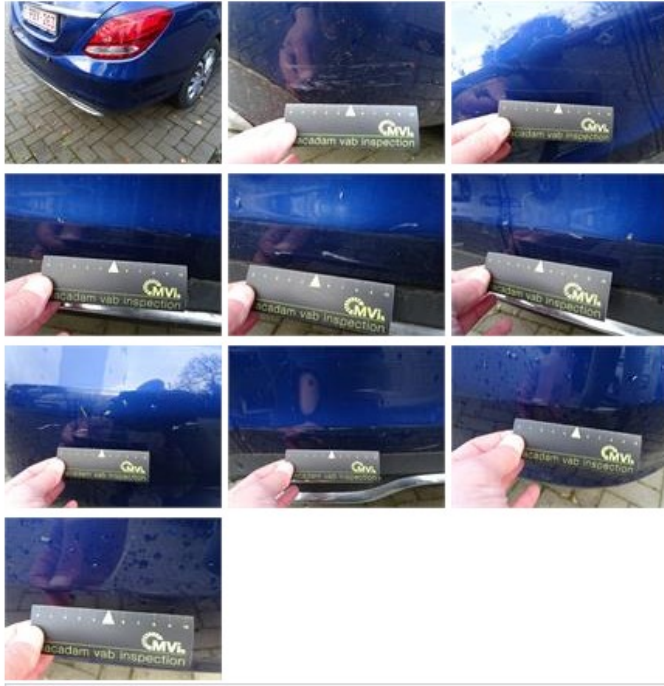
Bumper R, Scratch(es), LI - Repair and paint (complete) 211,80

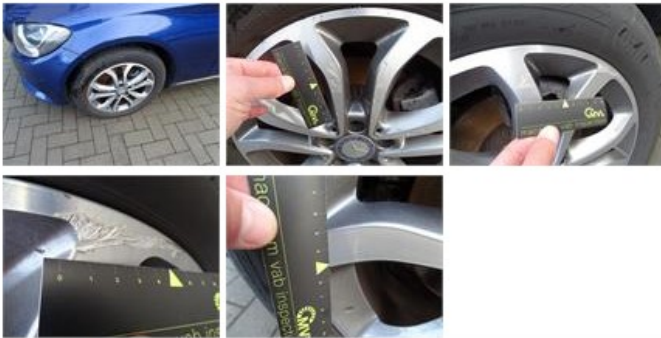
Alloy rim F L polished, Scratch(es), E - Replace

235,20

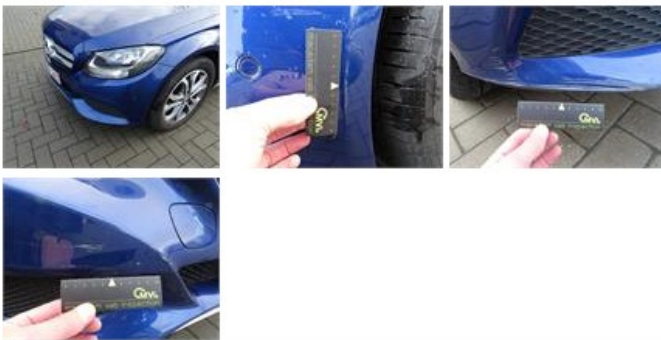
Bumper F, Scratch(es), LI - Repair and paint (complete)

211,80

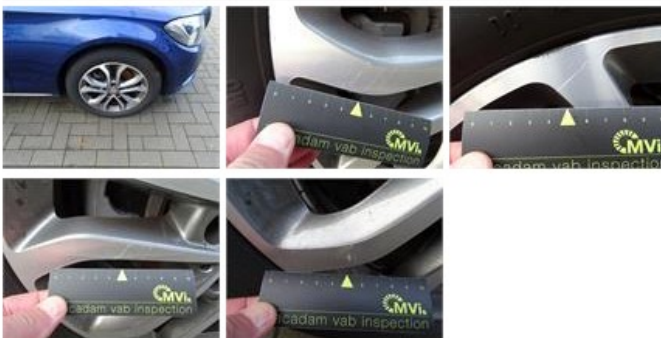
Alloy rim F R polished, Scratch(es), LI - Repair and paint (complete)

95,00
