MERCEDES E: 1FSU311

Limited Technical Inspection

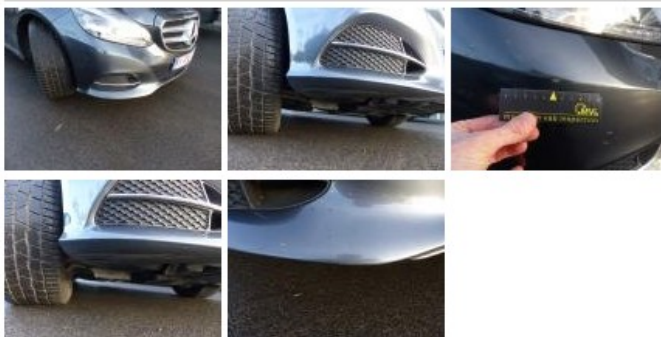
Front bumper, Scratch(es), It - Spot repair **115,56**
