**RENAULT Megane: 1EAN676**

**Limited Technical Inspection**

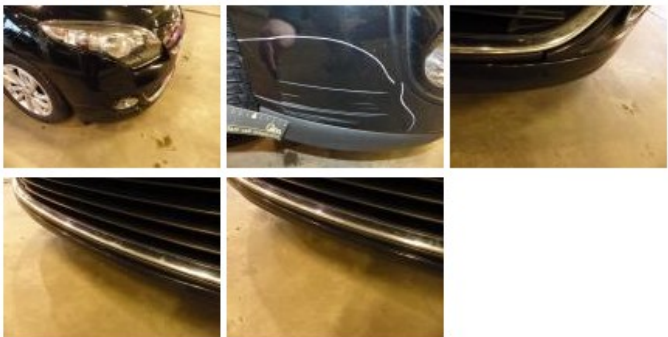
Total cost ex VAT	<b>1726,49</b>
Door F L, Scratch(es), Acceptable	<b>0,00</b>
<i>No pictures to display</i>	
Front bumper, Scratch(es), LI - Repair and paint (complete)	<b>211,80</b>
