**TOYOTA Auris: 1GAM841**

Vinnnumber:	<b>SB1ZS3JE90E062002</b>	Versionname:	<b>AURIS TOUR.SP. HSD Comfort CVT 99PK Aut.</b>
First Registrationdate:	<b>6/12/2013</b>	Fiscalpower:	
Expertise Mileage:	<b>106644</b>	Power Kw:	<b>73</b>
Bodytype:	<b>Break</b>	Body color:	<b>White</b>
Gearbox:	<b>Automatic</b>	Paint type:	<b>Opaque</b>
Transmission:	<b>Front</b>	Rims summer:	<b>Aluminium</b>
Fueltype:	<b>Hybrid Petrol</b>	Oil level:	<b>OK</b>
Battery functioning:	<b>Yes</b>	Parking lot:	<b>1105</b>
Number of doors:	<b>5</b>		
Number of seats:	<b>5</b>		
Number head rests:	<b>5</b>		
Rims summer:	<b>Aluminium</b>		
Category:	<b>VS</b>		
Oil level:	<b>OK</b>		
Registration Certificate Car (BE):	<b>Yes</b>

**Limited Technical Inspection**

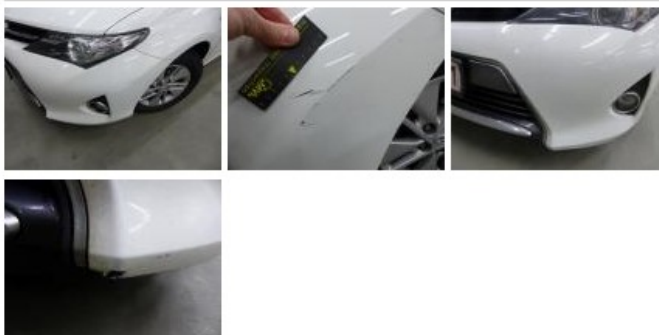
Front bumper, Scratch(es), LI - Repair and paint (complete) **211,80**

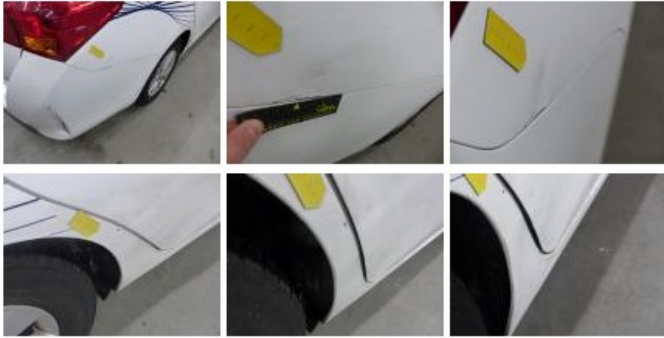
Bodywork, Not original part, Remove lettering	0,00
<i>No pictures to display</i>	
Door F L, Scratch(es), Acceptable	0,00
<i>No pictures to display</i>	
Wing R R, Bump(s) and scratch(es), LI - Repair and paint (complete)	356,20
