BMW 3 BERLINE: 1KLS158

Limited Technical Inspection

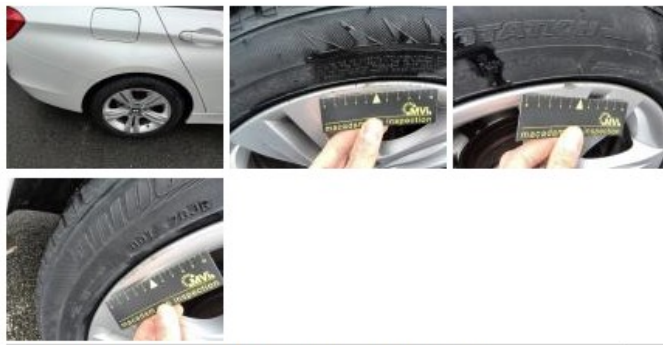
Backrest cover F L, Worn, Acceptable	0,00
<i>No pictures to display</i>	
Alloy rim R R, Scratch(es), LI - Repair and paint (complete)	95,00

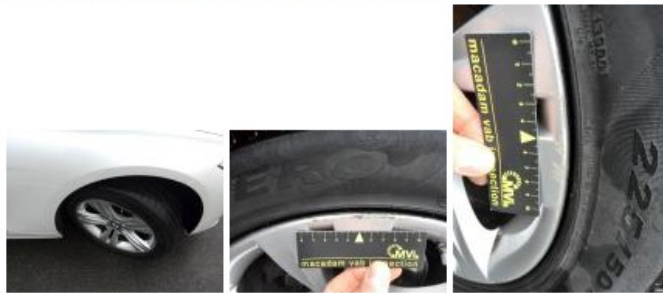
Alloy rim F R, Scratch(es), LI - Repair and paint (complete)	95,00
--	-------
