**VOLVO V40: 1EBM054**

**Limited Technical Inspection**

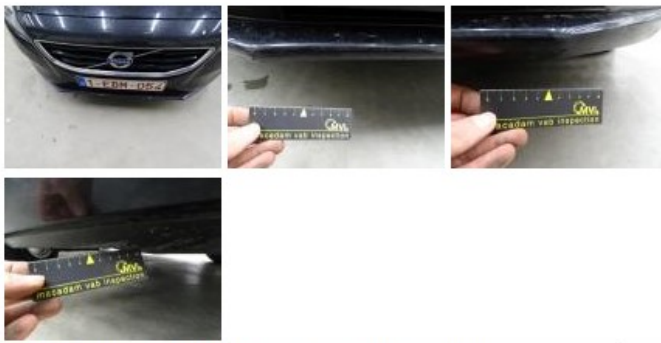
Front bumper, Scratch(es), LI - Repair and paint (complete)	<b>211,80</b>
-------------------------------------------------------------	---------------
