CITRO?N C5: 1EMF072

Limited Technical Inspection

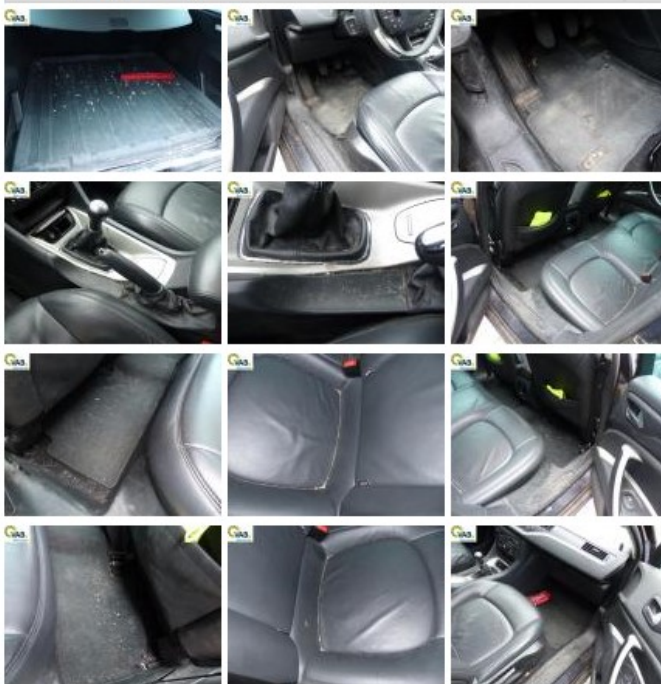
Total cost ex VAT	1596,78
Windscreen, Stone chip(s), Windscreen repair	58,80

Front bumper, Scratch(es), LI - Repair and paint (complete)	211,80
---	--------

Ignition key, Missing, E - Replace 72,00

Bumper R, Hole, Le - Replace and paint 579,00

Alloy rim F R, Scratch(es), LI - Repair and paint (complete) 95,00

Tailgate, Bump(s), LI - Repair and paint (complete) 301,68

Wing F R, Scratch(es), LI - Repair and paint (complete) 220,18

Interior, Dirty, Cleaning 58,32
