**BMW 520 D: 1EYH109**

**Limited Technical Inspection**

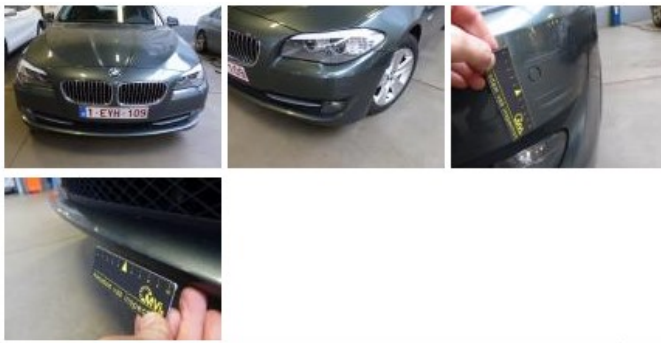
Runflat	<b>Yes</b>
Total cost ex VAT		254,16
Alloy rim R L, Scratch(es), Acceptable		0,00
<i>No pictures to display</i>		
Door R R, Stone chip(s), Acceptable		0,00
<i>No pictures to display</i>		
Rearview mirror housing L, Scratch(es), Acceptable		0,00
<i>No pictures to display</i>		
Front bumper, Scratch(es), LI - Repair and paint (complete)		254,16

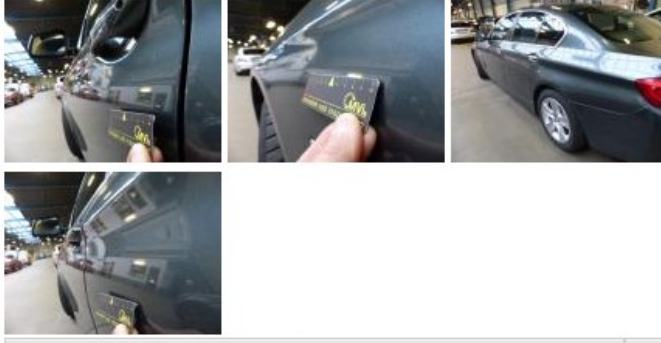
Bodywork, Repaired, P - Check 0,00
