**FORD Grand C-Max: 1ELS136**

**Limited Technical Inspection**

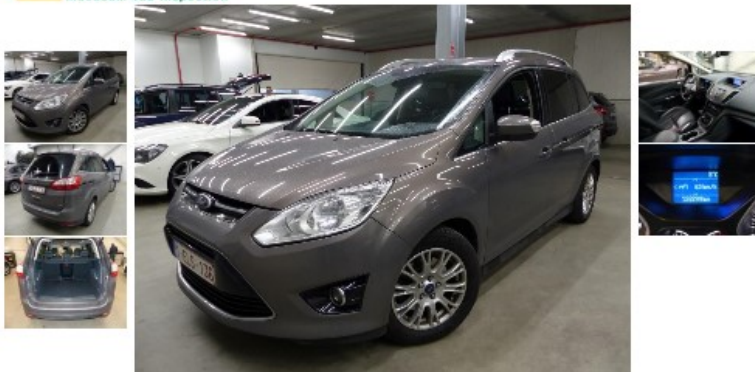
Vinnnumber:	<b>WFOHXXWPBHCS48828</b>	Versionname:	<b>GR.C-MAX Titanium St/St</b>
First Registrationdate:	<b>16/01/2013</b>	Fiscalpower:	<b>115PK</b>
Expertise Mileage:	<b>128299</b>	Power Kw:	<b>85</b>
Bodytype:	<b>MPV</b>	Body color:	<b>Brown</b>
Gearbox:	<b>MAN 6 VIT</b>	Paint type:	<b>Metalic</b>
Transmission:	<b>Front</b>	Rims summer:	<b>Aluminium</b>
Fueltype:	<b>Diesel</b>	Oil level:	<b>OK</b>
Battery functioning:	<b>Yes</b>	Parking lot:	<b>2606</b>
Number of doors:	<b>5</b>		
Number of seats:	<b>5</b>		
Number head rests:	<b>5</b>		
Rims summer:	<b>Aluminium</b>		
Category:	<b>Passenger Car</b>		
Oil level:	<b>OK</b>
