VOLKSWAGEN Golf Break: 1EEW629

Limited Technical Inspection

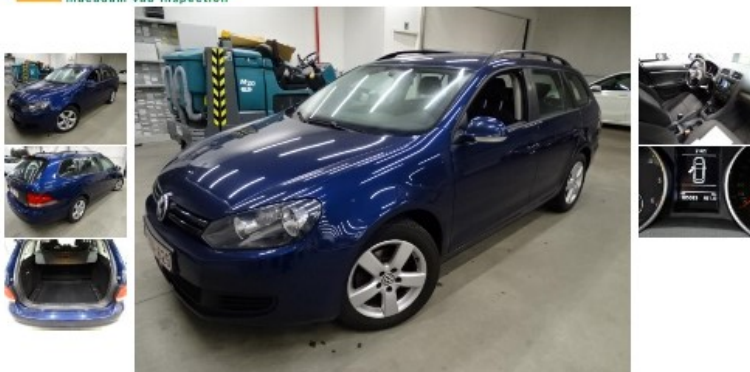
Vinnumber:	WVWZZZ1KZDM633572	Versionname:	GOLF BRE Trendline BlueMot.DPF 105PK
First Registrationdate:	12/11/2012	Fiscalpower:	
Expertise Mileage:	185583	Power Kw:	77
Bodytype:	Break	Body color:	Blue
Gearbox:	MAN 5 VIT	Paint type:	Metalic
Transmission:		Rims summer:	Aluminium
Fueltype:	Diesel	Oil level:	OK
Battery functioning:	Yes	Parking lot:	2303
Number of doors:	5		
Number of seats:	5		
Number head rests:	5		
Rims summer:	Aluminium		
Category:	Passenger Car		
Oil level:	OK
