AUDI A6: 1FQQ727			
Vinnumber:	WAUZZZ4G4EN052537	Versionname:	A6 AVANT 136PK
First Registrationdate:	25/09/2013	Fiscalpower:	
Expertise Mileage:	183835	Power Kw:	100
Bodytype:	Break	Body color:	Dark Blue
Gearbox:	MAN 6 VIT	Paint type:	Metalic
Transmission:	Front	Rims summer:	Aluminium
Fueltype:	Diesel	Oil level:	OK
Battery functioning:	Yes	Parking lot:	3712
Number of doors:	5		
Number of seats:	5		
Number head rests:	5		
Rims summer:	Aluminium		
Category:	Passenger Car		
Oil level:	OK		
Registration Certificate Car (BE):	Yes

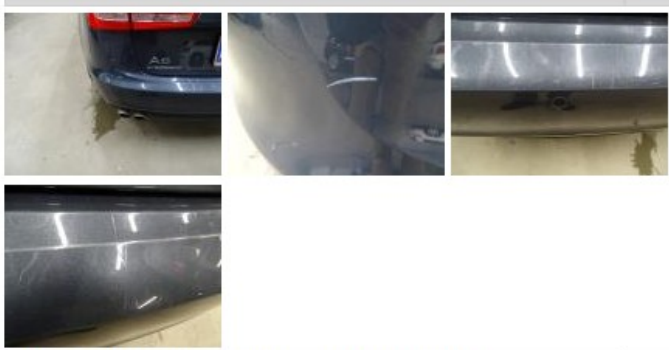
Assistance equipment			
Repair kit	Yes	Compressor	Yes
Total cost ex VAT			698,32
Bumper R, Scratch(es), LI - Repair and paint (complete)			254,16
