VOLVO V60: 1EMA927

Limited Technical Inspection

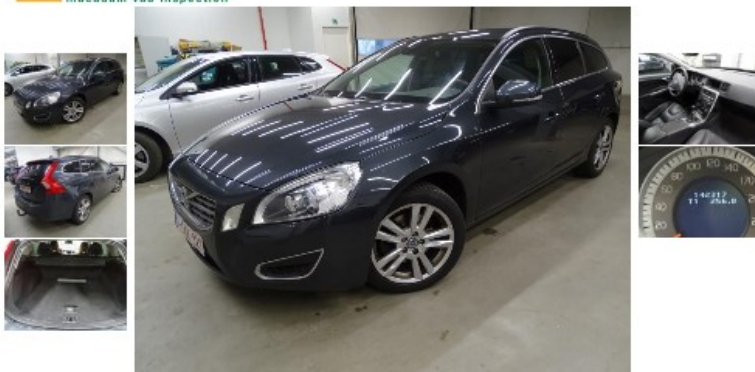
Vinnnumber:	YV1FW31A1D1121864	Versionname:	V60 D3 Kinetic St/St
First Registrationdate:	18/01/2013	Fiscalpower:	136PK
Expertise Mileage:	142317	Power Kw:	100
Bodytype:	Break	Body color:	Dark Grey
Gearbox:	MAN 6 VIT	Paint type:	Metalic
Transmission:	Front	Rims summer:	Aluminium
Fueltype:	Diesel	Oil level:	OK
Battery functioning:	Yes	Parking lot:	1512
Number of doors:	5		
Number of seats:	5		
Number head rests:	5		
Rims summer:	Aluminium		
Category:	Passenger Car		
Oil level:	OK
