OPEL Zafira: 1FQU907			
Vinnnumber:	WOLPD9EN7E2004827	Versionname:	ZAFIRA TOURER Enjoy Active 165PK Aut.
First Registrationdate:	26/09/2013	Fiscalpower:	
Expertise Mileage:	154486	Power Kw:	121
Bodytype:		Body color:	Brown
Gearbox:	Automatic	Paint type:	Metalic
Transmission:		Rims summer:	Steel
Fueltype:	Diesel	Oil level:	OK
Battery functioning:	Yes	Parking lot:	1532
Number of doors:	5		
Number of seats:	5		
Number head rests:	5		
Rims summer:	Steel		
Category:	Passenger Car		
Oil level:	OK		
Registration Certificate Car (BE):	Yes

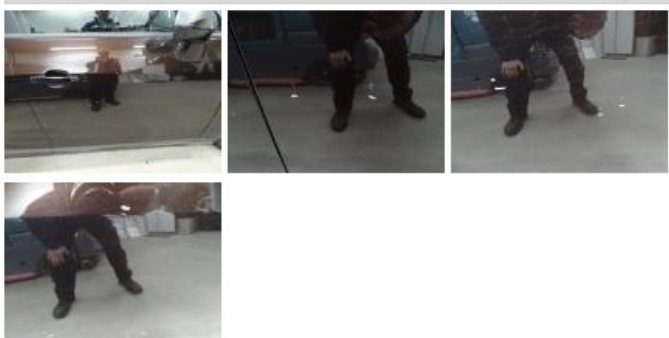
Assistance equipment	
Spare wheel	Yes Jack Yes
Total cost ex VAT	980,23
Door R R, Scratch(es), Acceptable	0,00
<i>No pictures to display</i>	
Door F R, Scratch(es), LI - Repair and paint (complete)	318,35
