OPEL VIVARO: 1NHJ607

Limited Technical Inspection

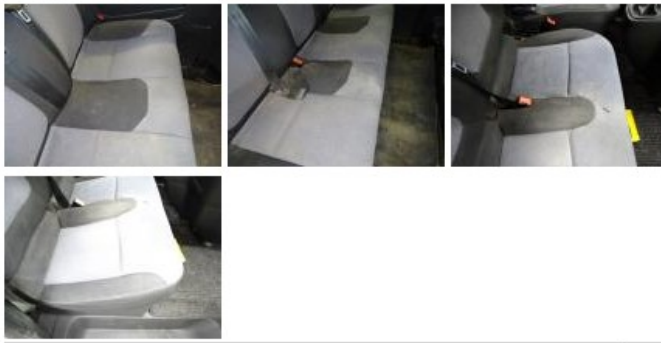
Interior, Dirty, Cleaning	100,00
---------------------------	--------
