OPEL Insignia: 1JCA314

Limited Technical Inspection

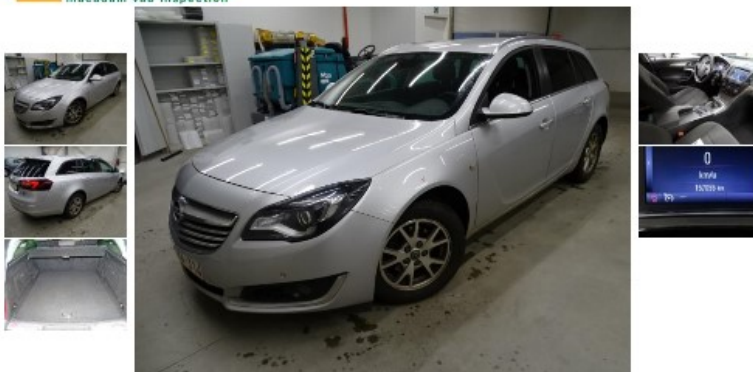
Total cost ex VAT	190,00
Bonnet, Scratch(es), Acceptable	0,00
<i>No pictures to display</i>	
Alloy rim F L, Scratch(es), LI - Repair and paint (complete)	95,00
