SKODA Octavia: 1EGP467			
Vinnnumber:	TMBHT21ZXD2092893	Versionname:	OCTAVIA COMBI GTec Ambition DPF 105PK
First Registrationdate:	27/11/2012	Fiscalpower:	
Expertise Mileage:	149167	Power Kw:	77
Bodytype:	Break	Body color:	Burgundy
Gearbox:	MAN 5 VIT	Paint type:	Metalic
Transmission:	Front	Rims summer:	Aluminium
Fueltype:	Diesel	Oil level:	OK
Battery functioning:	Yes	Parking lot:	3832
Number of doors:	5		
Number of seats:	5		
Number head rests:	5		
Rims summer:	Aluminium		
Category:	Passenger Car		
Oil level:	OK

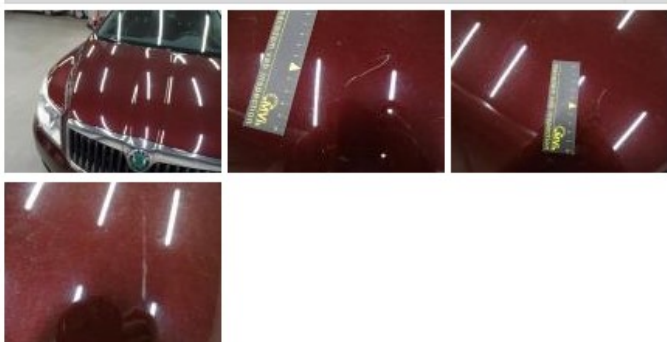
Assistance equipment			
Spare wheel	Yes	Jack	Yes
Total cost ex VAT			2225,76
Bonnet, Scratch(es), LI - Repair and paint (complete)			290,08

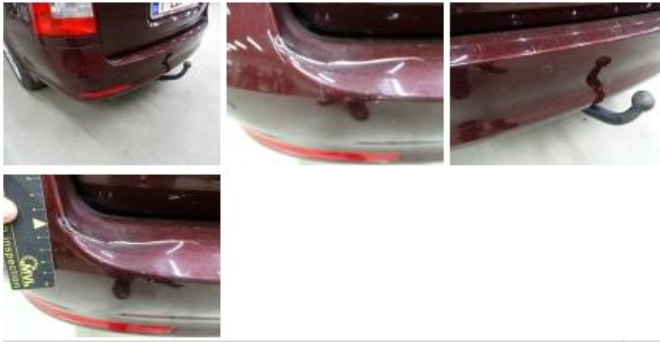
Bumper R, Damaged, E - Replace and paint 0,00
