VOLKSWAGEN Golf: 1FVU259			
Vinnnumber:	WVWZZZAUZEP534698	Versionname:	GOLF VAR Trendline 105PK
First Registrationdate:	12/11/2013	Fiscalpower:	
Expertise Mileage:	126070	Power Kw:	77
Bodytype:	Break	Body color:	Grey
Gearbox:	MAN 5 VIT	Paint type:	Metalic
Transmission:		Rims summer:	Steel
Fueltype:	Diesel	Oil level:	OK
Battery functioning:	Yes	Parking lot:	3602
Number of doors:	5		
Number of seats:	5		
Number head rests:	5		
Rims summer:	Steel		
Category:	Passenger Car		
Oil level:	OK		
Registration Certificate Car (BE):	Yes

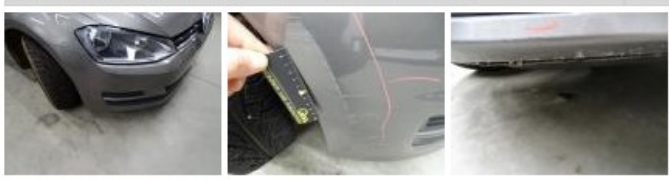
Total cost ex VAT	511,98
Bumper R, Scratch(es), Acceptable	0,00
<i>No pictures to display</i>	
Front bumper, Scratch(es), LI - Repair and paint (complete)	211,80

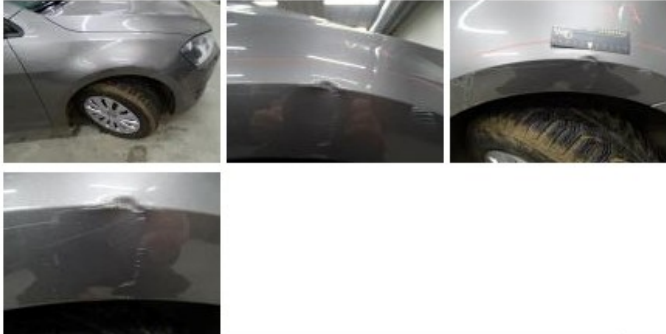
Door R R, Scratch(es), Acceptable	0,00
<i>No pictures to display</i>	
Wing F R, Bump(s) and scratch(es), LI - Repair and paint (complete)	220,18
