<b>BMW 5: YE8961</b>			
Vinnumber:	<b>WBAMX11000DU40646</b>	Versionname:	<b>5 TOURING 520dA 184PK Aut.</b>
First Registrationdate:	<b>22/08/2011</b>	Fiscalpower:	
Expertise Mileage:	<b>126940</b>	Power Kw:	<b>135</b>
Bodytype:	<b>Break</b>	Body color:	<b>Silver</b>
Gearbox:	<b>Automatic</b>	Paint type:	<b>Metalic</b>
Transmission:	<b>Back</b>	Rims summer:	<b>Aluminium</b>
Fueltype:	<b>Diesel</b>	Oil level:	<b>OK</b>
Battery functioning:	<b>Yes</b>	Parking lot:	<b>2503</b>
Number of doors:	<b>5</b>		
Number of seats:	<b>5</b>		
Number head rests:	<b>5</b>		
Rims summer:	<b>Aluminium</b>		
Category:	<b>Passenger Car</b>		
Oil level:	<b>OK</b>		
Registration Certificate Car (BE):	<b>Yes</b>

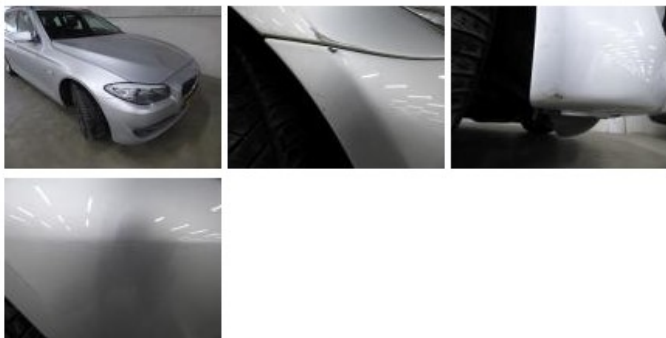
<b>Assistance equipment</b>			
Repair kit	<b>Yes</b>	Compressor	<b>Yes</b>
<b>Total cost ex VAT</b>			<b>1843,08</b>
<b>Bumper F R, Scratch(es), It - Spot repair</b>			<b>115,56</b>
