MERCEDES B: 1DPI681			
Vinnumber:	WDD2462001J081352	Versionname:	B 180 CDI BE 109PK
First Registrationdate:	13/07/2012	Fiscalpower:	
Expertise Mileage:	177262	Power Kw:	80
Bodytype:	Hatchback	Body color:	Dark Brown
Gearbox:	MAN 6 VIT	Paint type:	Metalic
Transmission:	Front	Rims summer:	Aluminium
Fueltype:	Diesel	Oil level:	OK
Battery functioning:	Yes	Parking lot:	2728
Number of doors:	5		
Number of seats:	5		
Number head rests:	5		
Rims summer:	Aluminium		
Category:	Passenger Car		
Oil level:	OK

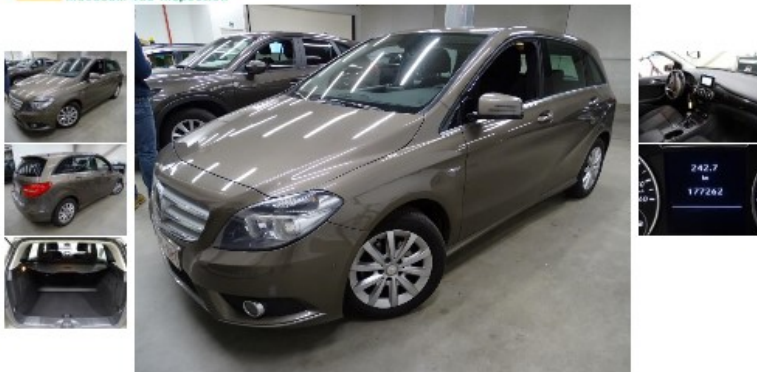
Assistance equipment			
Repair kit	Yes	Compressor	Yes
Total cost ex VAT		274,80	
Bumper R, Scratch(es), Acceptable		0,00	
<i>No pictures to display</i>			
Door R L, Scratch(es), Acceptable		0,00	
<i>No pictures to display</i>			
Door R R, Bump(s), PDR - Knock out without painting		63,00	
<i>No pictures to display</i>			
Front bumper, Scratch(es), LI - Repair and paint (complete)		211,80
