## VOLKSWAGEN Golf: 1FXG441

## Limited Technical Inspection

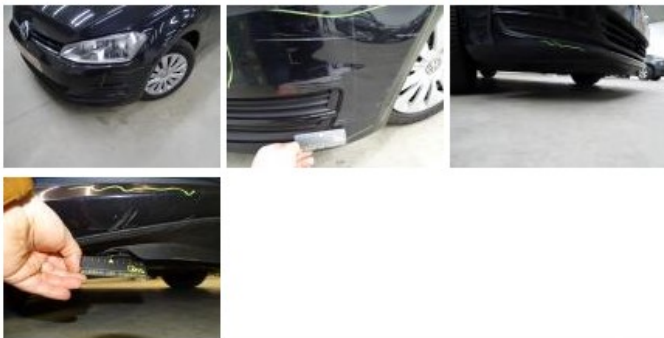
Door F R, Bump(s), Acceptable	0,00
<i>No pictures to display</i>	
Front bumper, Scratch(es), LI - Repair and paint (complete)	211,80

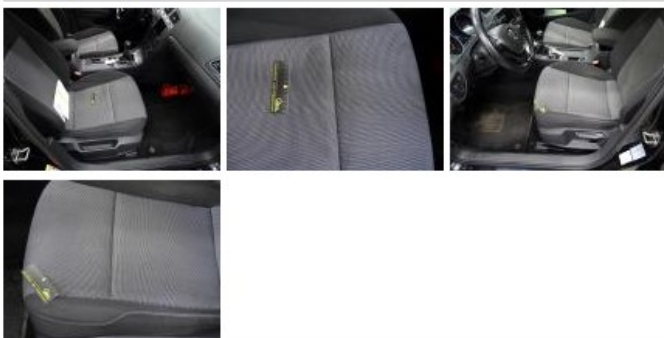
Interior, Stain, Cleaning	50,00
