**VOLKSWAGEN Touran: 1FRI265**

**Limited Technical Inspection**

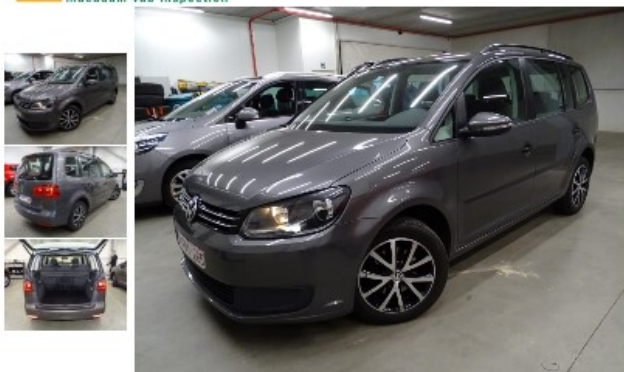
Vinnnumber:	<b>WVGZZ1TZEW028435</b>	Versionname:	<b>TOURAN Trendline BMT</b>
First Registrationdate:	<b>1/10/2013</b>	Fiscalpower:	<b>Start/Stop 105PK</b>
Expertise Mileage:	<b>148034</b>	Power Kw:	<b>77</b>
Bodytype:	<b>MPV</b>	Body color:	<b>Dark Grey</b>
Gearbox:	<b>MAN 6 VIT</b>	Paint type:	<b>Metalic</b>
Transmission:	<b>Front</b>	Rims summer:	<b>Aluminium</b>
Fueltype:	<b>Diesel</b>	Oil level:	<b>OK</b>
Battery functioning:	<b>Yes</b>	Parking lot:	<b>4220</b>
Number of doors:	<b>5</b>		
Number of seats:	<b>5</b>		
Number head rests:	<b>5</b>		
Rims summer:	<b>Aluminium</b>		
Category:	<b>Passenger Car</b>		
Oil level:	<b>OK</b>		
Registration Certificate Car (BE):	<b>Yes</b>
