**AUDI A6: 1GCY684**

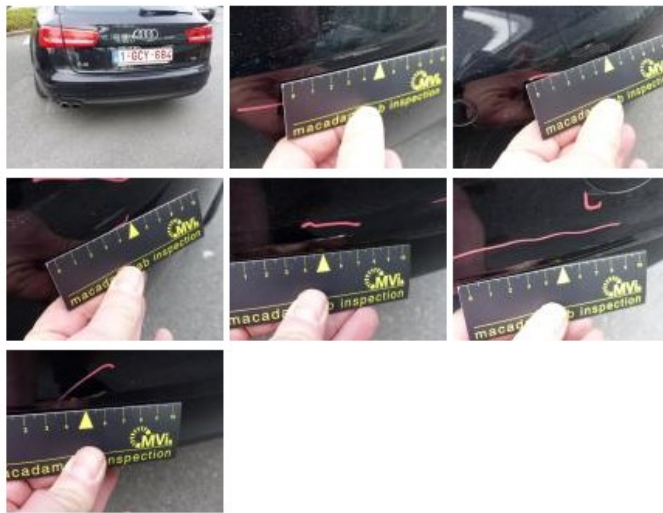
Bumper R, Scratch(es), LI - Repair and paint (complete)	<b>254,16</b>
---	---------------

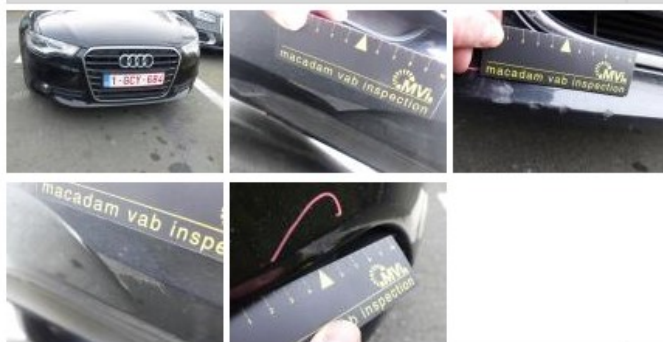
Bonnet, Chemical polution, Acceptable	0,00
<i>No pictures to display</i>	
Wing F L, Scratch(es), Acceptable	0,00
<i>No pictures to display</i>	
Front bumper, Scratch(es), LI - Repair and paint (complete)	254,16
