**RENAULT Grand Scenic: 1GAG395**

Vinnnumber:	<b>VF1JZNAB649970109</b>	Versionname:	<b>GRAND SCENIC Energy Zen 7pl.130PK</b>
First Registrationdate:	<b>5/12/2013</b>	Fiscalpower:	
Expertise Mileage:	<b>179999</b>	Power Kw:	<b>96</b>
Bodytype:	<b>MPV</b>	Body color:	<b>Grey</b>
Gearbox:	<b>MAN 6 VIT</b>	Paint type:	<b>Metalic</b>
Transmission:		Rims summer:	<b>Aluminium</b>
Fueltype:	<b>Diesel</b>	Oil level:	<b>OK</b>
Battery functioning:	<b>Yes</b>	Parking lot:	<b>2705</b>
Number of doors:	<b>5</b>		
Number of seats:	<b>7</b>		
Number head rests:	<b>7</b>		
Rims summer:	<b>Aluminium</b>		
Category:	<b>Passenger Car</b>		
Oil level:	<b>OK</b>		
Registration Certificate Car (BE):	<b>Yes</b>

**Limited Technical Inspection**

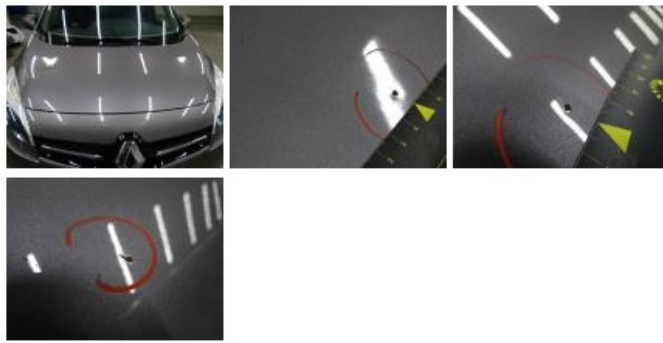
Rear window, Scratch(es), Acceptable	0,00
<i>No pictures to display</i>	
Bonnet, Rust, LI - Repair and paint (complete)	290,08
