BMW X3: 1GEH766

Limited Technical Inspection

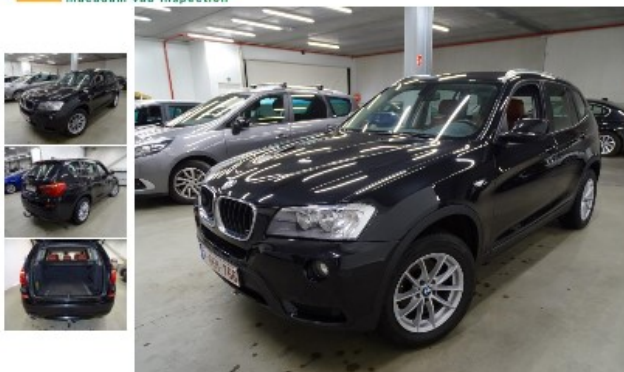
Vinnumber:	WBAWY110100C58020	Versionname:	X3 sDrive18 136PK
First Registrationdate:	15/01/2014	Fiscalpower:	
Expertise Mileage:	95261	Power Kw:	100
Bodytype:	SUV	Body color:	Black
Gearbox:	MAN 6 VIT	Paint type:	Metalic
Transmission:	Back	Rims summer:	Aluminium
Fueltype:	Diesel	Oil level:	OK
Maintenance:	01-2018	Parking lot:	3303
Maintenance:	NOT OK		
Battery functioning:	Yes		
Number of doors:	5		
Number of seats:	5		
Number head rests:	5		
Rims summer:	Aluminium		
Category:	Passenger Car		
Oil level:	OK		
Registration Certificate Car (BE):	Yes
