VOLKSWAGEN Sharan: 1GCV658

Limited Technical Inspection

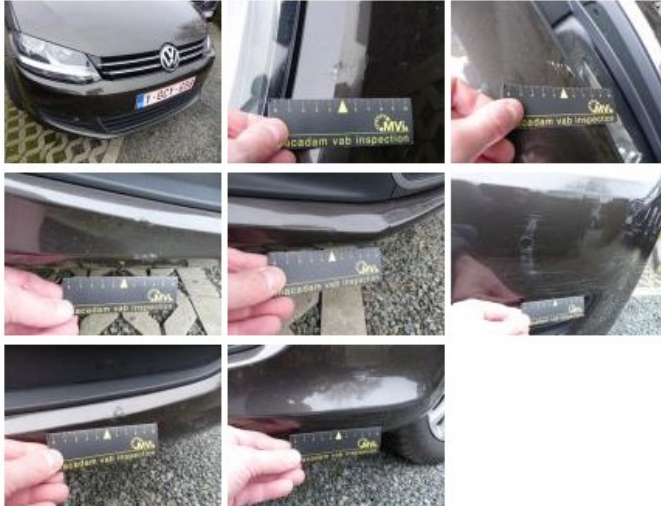
Wing R R, Scratch(es), Acceptable	0,00
<i>No pictures to display</i>	
Alloy rim F R, Scratch(es), Acceptable	0,00
<i>No pictures to display</i>	
Bumper R, Scratch(es), Acceptable	0,00
<i>No pictures to display</i>	
Alloy rim R L, Scratch(es), Acceptable	0,00
<i>No pictures to display</i>	
Front bumper, Bump(s) and scratch(es), LI - Repair and paint (complete)	302,16
