AUDI A4: 1EPN845

Limited Technical Inspection

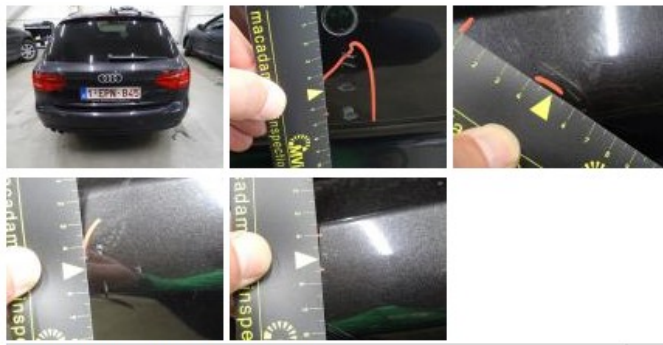
Total cost ex VAT	988,90
Bonnet, Stone chip(s), Acceptable	0,00
<i>No pictures to display</i>	
Tailgate, Scratch(es), Acceptable	0,00
<i>No pictures to display</i>	
Wing R R, Bump(s) and scratch(es), Acceptable	0,00
<i>No pictures to display</i>	
Door R L, Scratch(es), Acceptable	0,00
<i>No pictures to display</i>	
Rocker panel inner R R, Scratch(es), Acceptable	0,00
<i>No pictures to display</i>	
Bumper R, Scratch(es), LI - Repair and paint (complete)	211,80
