PEUGEOT 308 SW: 1FWU391

Limited Technical Inspection

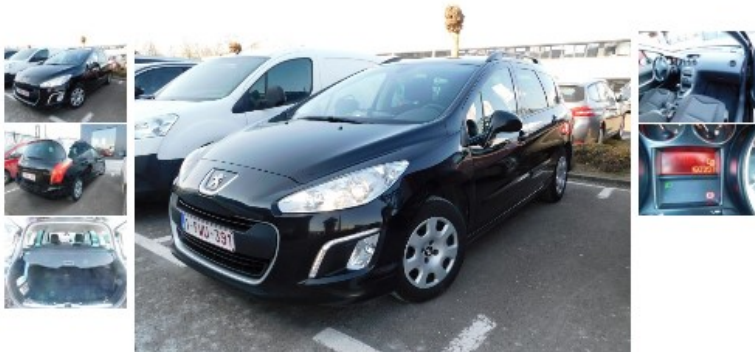
Vinnumber:	VF34E9HP0DS216808	Versionname:	1.6 HDI
First Registrationdate:	21/11/2013	Fiscalpower:	
Expertise Mileage:	160391	Power Kw:	68
Bodytype:		Body color	Black
Gearbox:	MAN 5 VIT	Paint type	Metalic
Transmission:	Front	Rims summer	Steel
Fueltype:	Diesel	Oil level	OK
Maintenance	OK	Parking lot	3526
Battery functioning	Yes		
Number of doors	5		
Number of seats	5		
Number head rests	5		
Rims summer	Steel		
Category	Passenger Car		
Oil level	OK		
Registration Certificate Car (BE)	Yes
