| RENAULT Grand Scenic: 1ERM213 | | | |
| Vinnnumber: | <b>VF1JZ14A648605767</b> | Versionname: | <b>GR.SCENIC Energ.Expression 5Pl.FAP</b> |

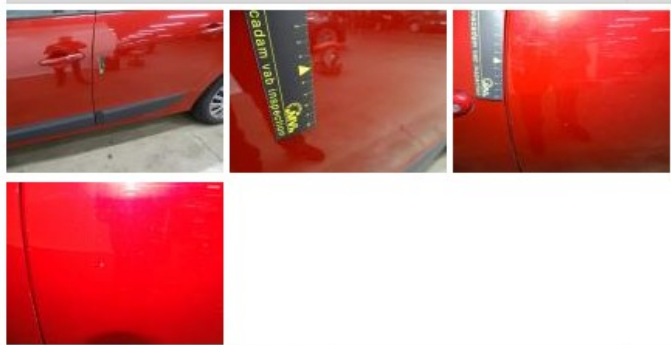
| Assistance equipment | | | |
|---|---|---|---|
| Door R L, Bump(s) and scratch(es), LI - Repair and paint (complete) | | | <b>318,35</b> |
