VOLVO V60: 1FPV310			
Vinnnumber:	YV1FW8481E1166658	Versionname:	V60 BRE D2 Kinetic 115PK
First Registrationdate:	18/09/2013	Fiscalpower:	
Expertise Mileage:	116374	Power Kw:	84
Bodytype:	Break	Body color:	Silver
Gearbox:	MAN 6 VIT	Paint type:	Metalic
Transmission:	Front	Rims summer:	Aluminium
Fueltype:	Diesel	Oil level:	OK
Battery functioning:	Yes	Parking lot:	2313
Number of doors:	5		
Number of seats:	5		
Number head rests:	5		
Rims summer:	Aluminium		
Category:	Passenger Car		
Oil level:	OK		
Registration Certificate Car (BE):	Yes

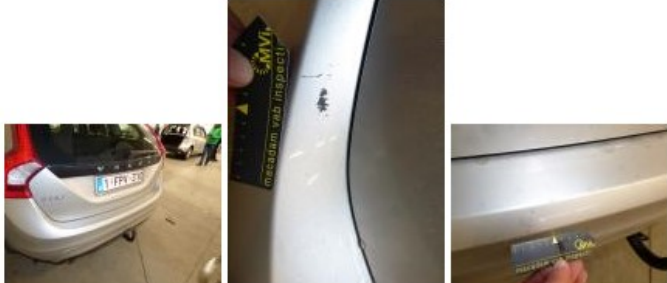
Assistance equipment			
Repair kit	Yes	Compressor	Yes
Total cost ex VAT			1347,62
Bumper R, Scratch(es), LI - Repair and paint (complete)			211,80
