RENAULT Scenic: 1GKL572

Limited Technical Inspection

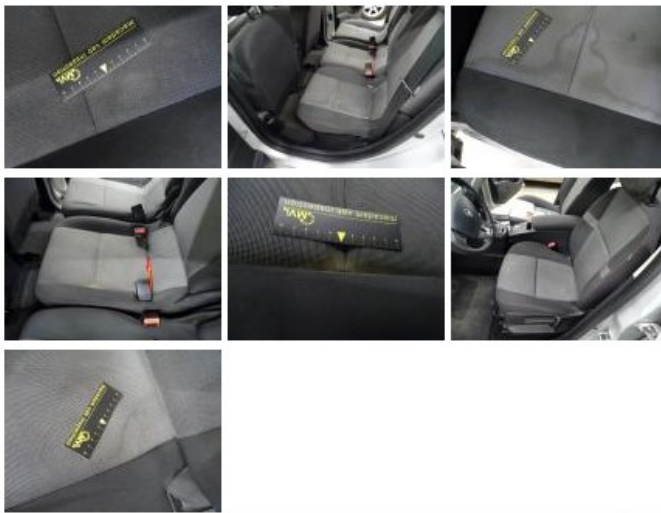
Total cost ex VAT	530,64
Tailgate, Scratch(es), Acceptable	0,00
<i>No pictures to display</i>	
Door F R, Bump(s), Acceptable	0,00
<i>No pictures to display</i>	
Interior, Stain, Cleaning	125,00
