VOLKSWAGEN PASSAT: 1GGO022

Limited Technical Inspection

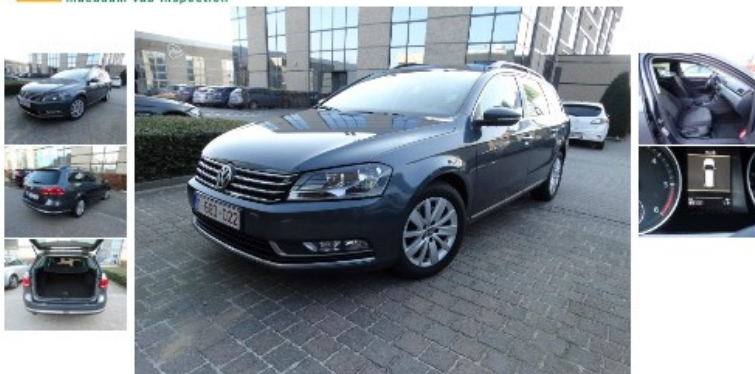
Vinnnumber:	WVWZZ3CZEE108102	Versionname:	VAR Comfortline BMT 105PK
First Registrationdate:	3/02/2014	Fiscalpower:	
Expertise Mileage:	99131	Power Kw:	77
Bodytype:	Break	Body color:	Grey
Gearbox:	MAN 6 VIT	Paint type:	Metalic
Transmission:	Front	Rims summer:	Aluminium
Fueltype:	Diesel	Oil level:	OK
Maintenance:	OK	Parking lot:	4502
Maintenance:	OVER 14600 KM		
Battery functioning:	Yes		
Number of doors:	5		
Number of seats:	5		
Number head rests:	5		
Rims summer:	Aluminium		
Category:	Passenger Car		
Oil level:	OK		
Registration Certificate Car (BE):	Yes
