VOLVO V60: 1DUR323			
Vinnnumber:	YV1FW31A0D1102695	Versionname:	V60 D3 Kinetic St/St Geartr.136PK Aut.
First Registrationdate:	3/09/2012	Fiscalpower:	
Expertise Mileage:	114074	Power Kw:	100
Bodytype:	Break	Body color:	Dark Brown
Gearbox:	Automatic	Paint type:	Metalic
Transmission:	Front	Rims summer:	Aluminium
Fueltype:	Diesel	Oil level:	OK
Battery functioning:	Yes	Parking lot:	4219
Number of doors:	5		
Number of seats:	5		
Number head rests:	5		
Rims summer:	Aluminium		
Category:	Passenger Car		
Oil level:	OK

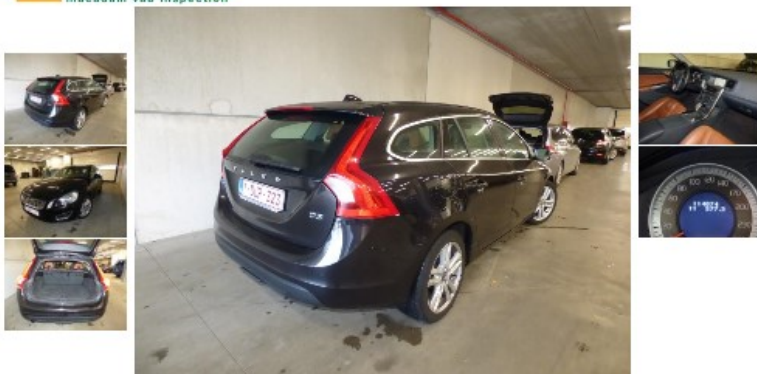
Front bumper, Scratch(es), LI - Repair and paint (complete)	211,80
---	--------

Front bumper, scratch(es), LI - Repair and paint (complete)
