BMW 3: 1ESV123

Limited Technical Inspection

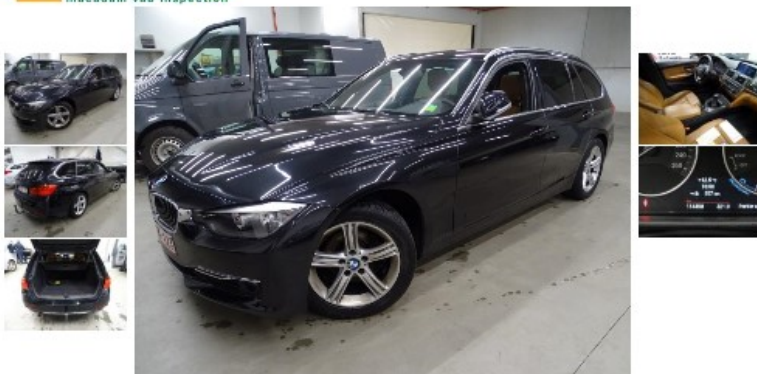
Vinnumber:	WBA3K11050F820953	Versionname:	3 TOURING 318d 136PK
First Registrationdate:	12/03/2013	Fiscalpower:	
Expertise Mileage:	114498	Power Kw:	100
Bodytype:	Break	Body color:	Black
Gearbox:	MAN 6 VIT	Paint type:	Metalic
Transmission:	Back	Rims summer:	Aluminium
Fueltype:	Diesel	Oil level:	OK
Battery functioning:	Yes	Parking lot:	3725
Number of doors:	5		
Number of seats:	5		
Number head rests:	5		
Rims summer:	Aluminium		
Category:	Passenger Car		
Oil level:	OK
